# HIPO – San Juan South--Farmington Investigation Summary

**INCIDENT:** GCU 265E  
**TYPE OF INCIDENT:** HIPO  
**BUSINESS UNIT:** NAG – San Juan  
**LOCATION OF INCIDENT:** San Juan-Farmington  
**COUNTRY:** United States  
**Tr@ction No:** 2013-IR-4541850  
**DATE OF INCIDENT:** October 9, 2013

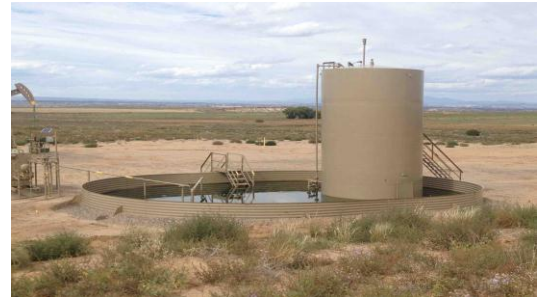
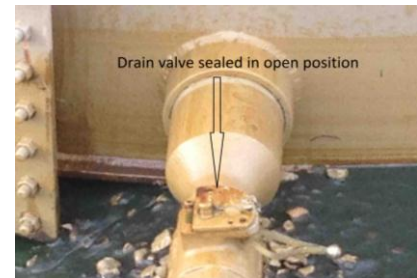
A contract gauger was draining water off the bottom of a 400-bbl production tank into an interconnected 95-bbl below-grade tank (BGT) to ready the larger tank for sale. After draining the produced water, the gauger intended to close and tag the drain valve on the bottom of the production tank, but instead fully opened the valve and tagged it as if it was closed. The gauger then left the location at approximately 8:45 a.m. The BGT subsequently overflowed inside the metal secondary containment ring surrounding the production tank and BGT. At 10:40 a.m. a contract compressor mechanic shut the GCU 265E facility in and notified a BP field tech of the incident. The BP field tech made other notifications to the Operations Specialist, Production Team Lead and contract gauger.

**Critical Factor 1** - Gauger failed to close the bottom tank valve following water drain activity.

**13.2 Behaviour - Antecedent not effective**—Gauger did not have an effective visual indication of valve position and the valve could be car sealed in either the open or closed position. (OMS 4.5 Control of Work)

- Evaluate if the valve locked open position holes can be plugged to prevent it from being locked in the wrong position. Evaluate the risk of reinstalling the valve handles and having them be disturbed by animals or other activity
