Lessons Learned Communication

Incident: Trackhoe boom severed overhead power lines

Location of Incident: Anadarko Asset, Ochiltree gathering system, Lipscomb County, Texas

HIPO: trackhoe contact with overhead power line (March 5, 2007)

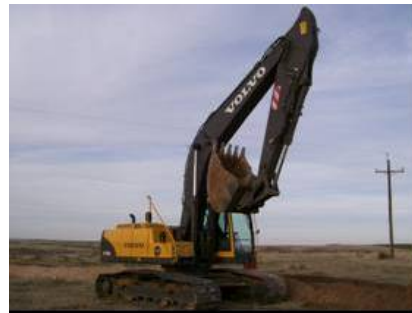
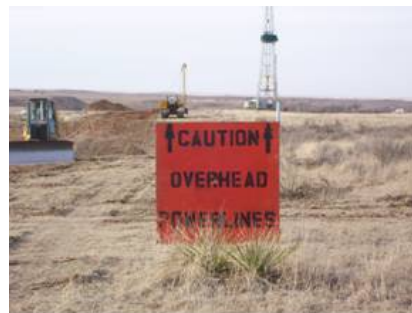
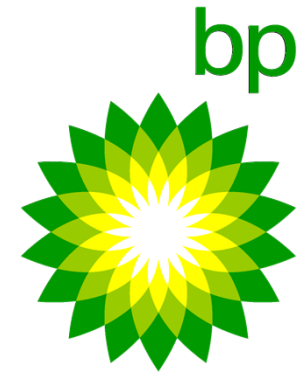
Trackhoe hit overhead powerline, while driving on right-of-way from one job to the next.

CF-1. Trackhoe boom was put in vertical position while driving on the right-of-way.

CF-2. Trackhoe operator drove into power lines.

CF-1. Anadarko should consider the use of task specific JSEA's for moving heavy equipment in addition to the full job JSEA.

CF-2. In this incident, the mitigation was not sufficient for the overhead power line hazard identified. The following recommendations address this issue:

1. Anadarko should use additional warning means, i.e. flashing beacons, caution tape, spotter with sole responsibility to assist vehicles passing under power lines as signage alone was not adequate enough to prevent this incident.
2. Anadarko should investigate means to verify onsite, the minimum required and actual clearance distance between top of equipment and power lines.

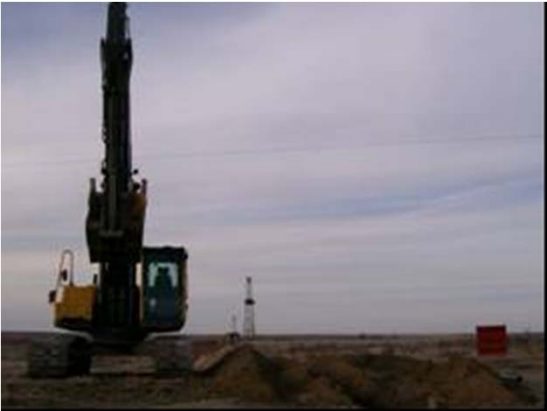
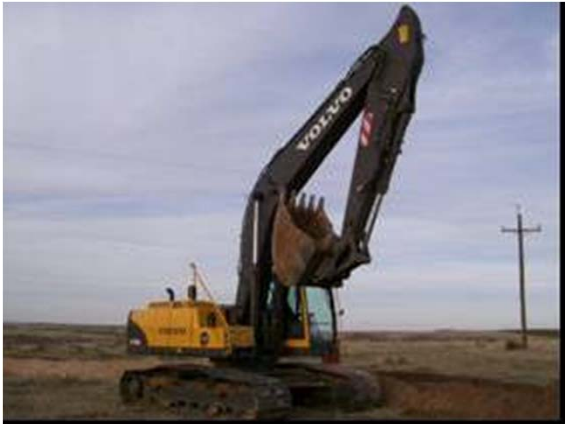
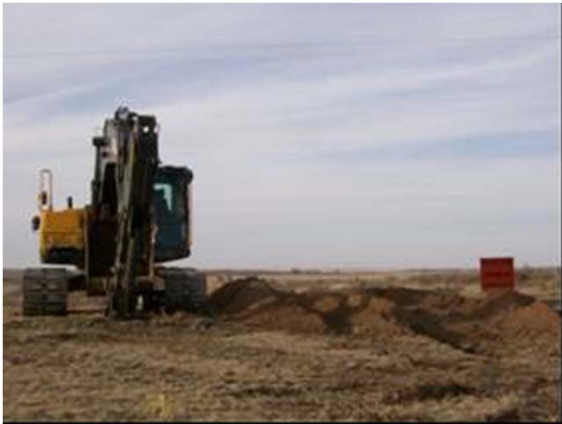
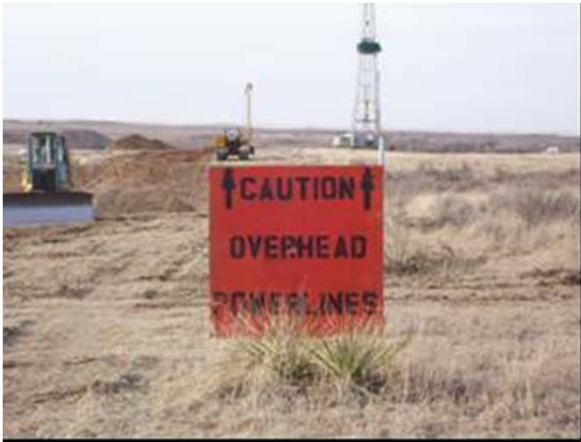
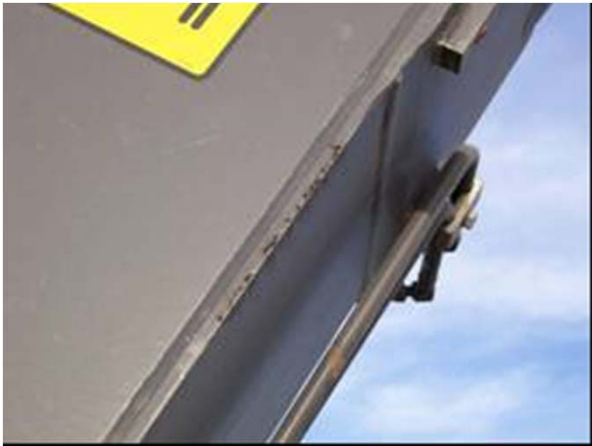
Photographs

CF-1. Trackhoe boom was put in vertical position while driving on the right-of-way.

CF-2. Trackhoe operator drove into power lines.

Anadarko should consider the use of task specific JSEA's for moving heavy equipment in addition to the full job JSEA.

In this incident, the mitigation was not sufficient for the overhead power line hazard identified. The following recommendations address this issue:

- Anadarko should use additional warning means, i.e. flashing beacons, caution tape, spotter with sole responsibility to assist vehicles passing under power lines as signage alone was not adequate enough to prevent this incident.
- Anadarko should investigate means to verify on site, the minimum required and actual clearance distance between top of equipment and power lines.
