**Incident: Electrical high-voltage shock**

**Business entity: BP Wind**

**Location of incident: Mehoopany, PA**

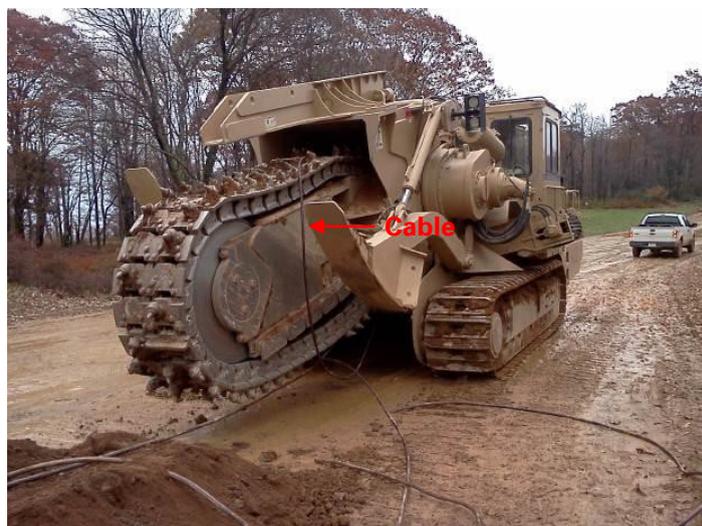
**What happened? :** A contract crew was installing the electrical collector system for a wind farm. The driver of the trenching machine digging a trench to lay the cable in severed a privately owned underground energized 7.2 kV cable. There was potential for exposure to an electrical shock to the driver, a team member who entered the trench after the cable was cut, and a backhoe operator working nearby. There were no injuries as a result of this incident.

The electrical energy was not switched off before work commenced.

The cable routing information was not available from the owner or the local utility. The contractor relied solely on electronic detection data for identification and marking of the underground lines. The execution of this marking was less than adequate.

Communication between the foreman and the driver failed to make clear the danger of trenching in the area the marking was not adequate.

1. Perform 100% electrical line detection ahead of the trenching machine.
2. Update the Ground Disturbance Permit to include requirements for the type of markers, electrical lockout isolation, verification of isolation, and BP notification for approval when near any electrical ground disturbance.
3. Contractors to be retrained on the content and use of the Ground Disturbance Permit.
4. Contractor to train their employees on their Excavation Safety Policy.
5. Develop and communicate a written site safety plan for any detected lines before work commences.
6. Employees and management of employees working around or on energized electrical equipment to have electrical training to understand the dangers of energized electrical system exposure.

1. Ensure that ground disturbance permits include requirements for type of markers, electrical lockout isolation, as well as verification of electrical isolation.
2. Employees and management of employees working around or on energized electrical equipment should have electrical training to understand the dangers of energized electrical system exposure and how to mitigate the risks of potential electrical energy.
