Lessons Learned Communication

Incident: Trackhoe boom severed overhead power lines

Location of Incident: Anadarko Asset, Ochiltree gathering system, Lipscomb County, Texas

HIPO: trackhoe contact with overhead power line (March 5, 2007)

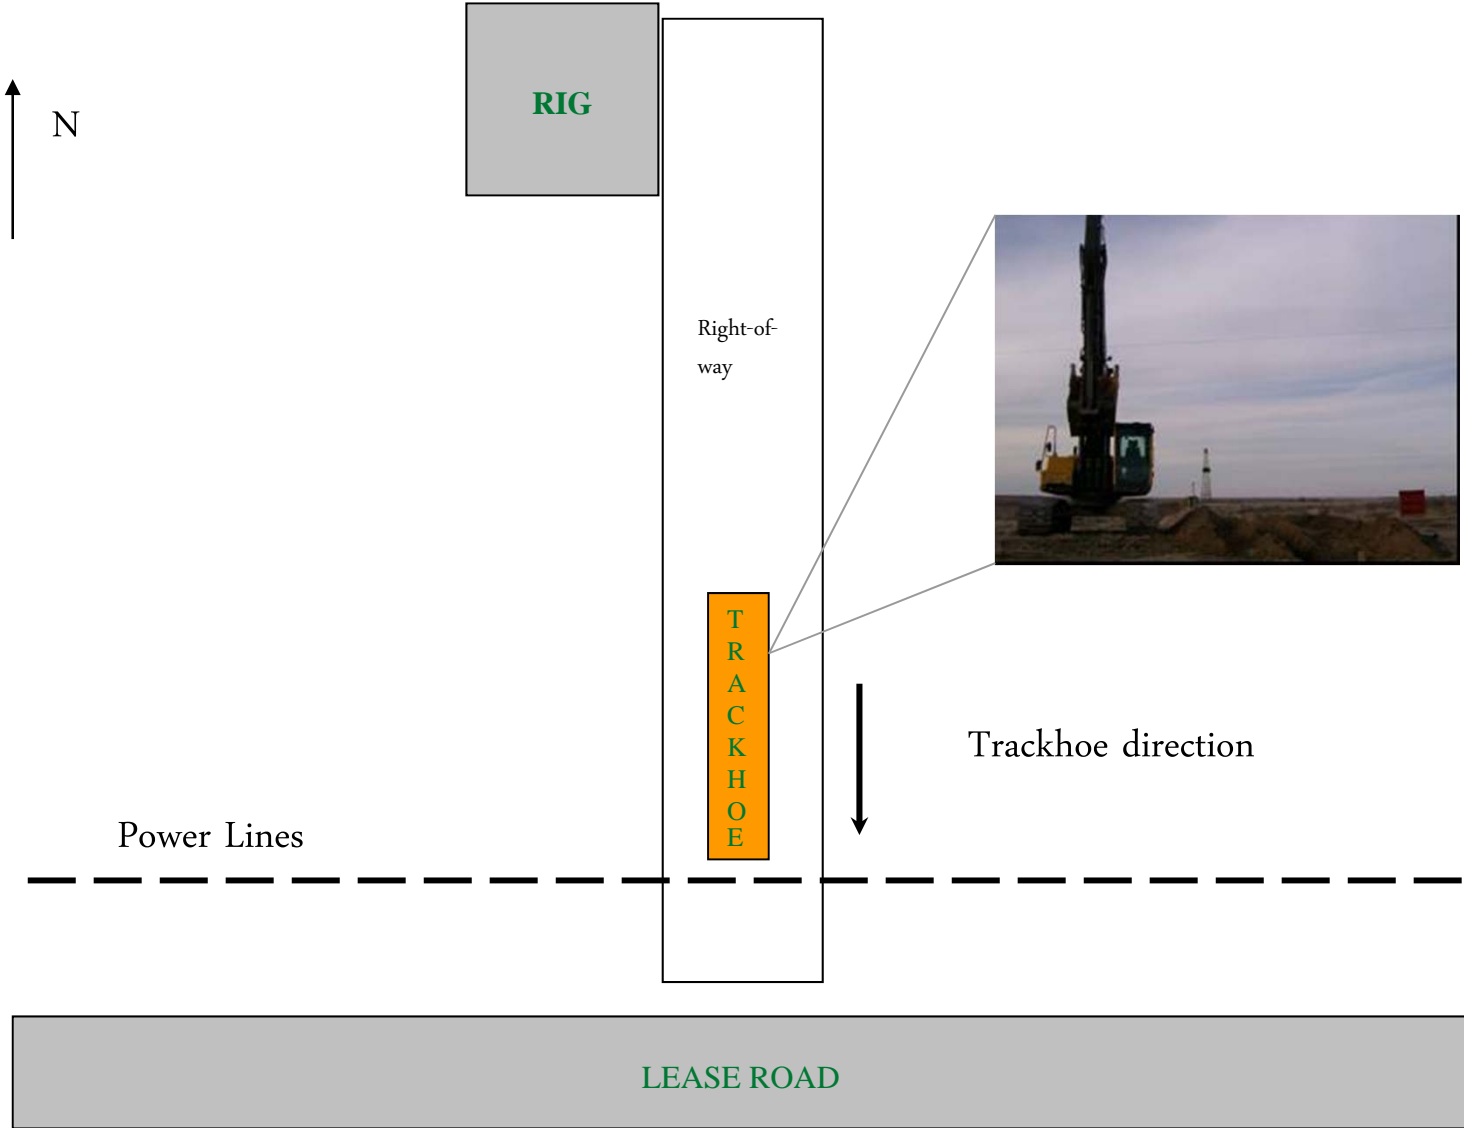
Site Plot Plan

- Construction crew was constructing new pipeline to tie in well.
- After finalising digging pipeline crossing, trackhoe operator lifted his boom into vertical position and proceeded to the next job location along the right-of-way.
- Operator had boom in up position to have better field of view while driving.
- Operator was focused on spotting trackhoe at new location and did not notice overhead power lines.
- Trackhoe hit and broke two overhead power lines.
- Operator got out of vehicle and incident command was notified.
- No one got hurt.
